MODEL 163.113 /128 /136 /154 /157 /172 /174 /175

P72.10-2740-06

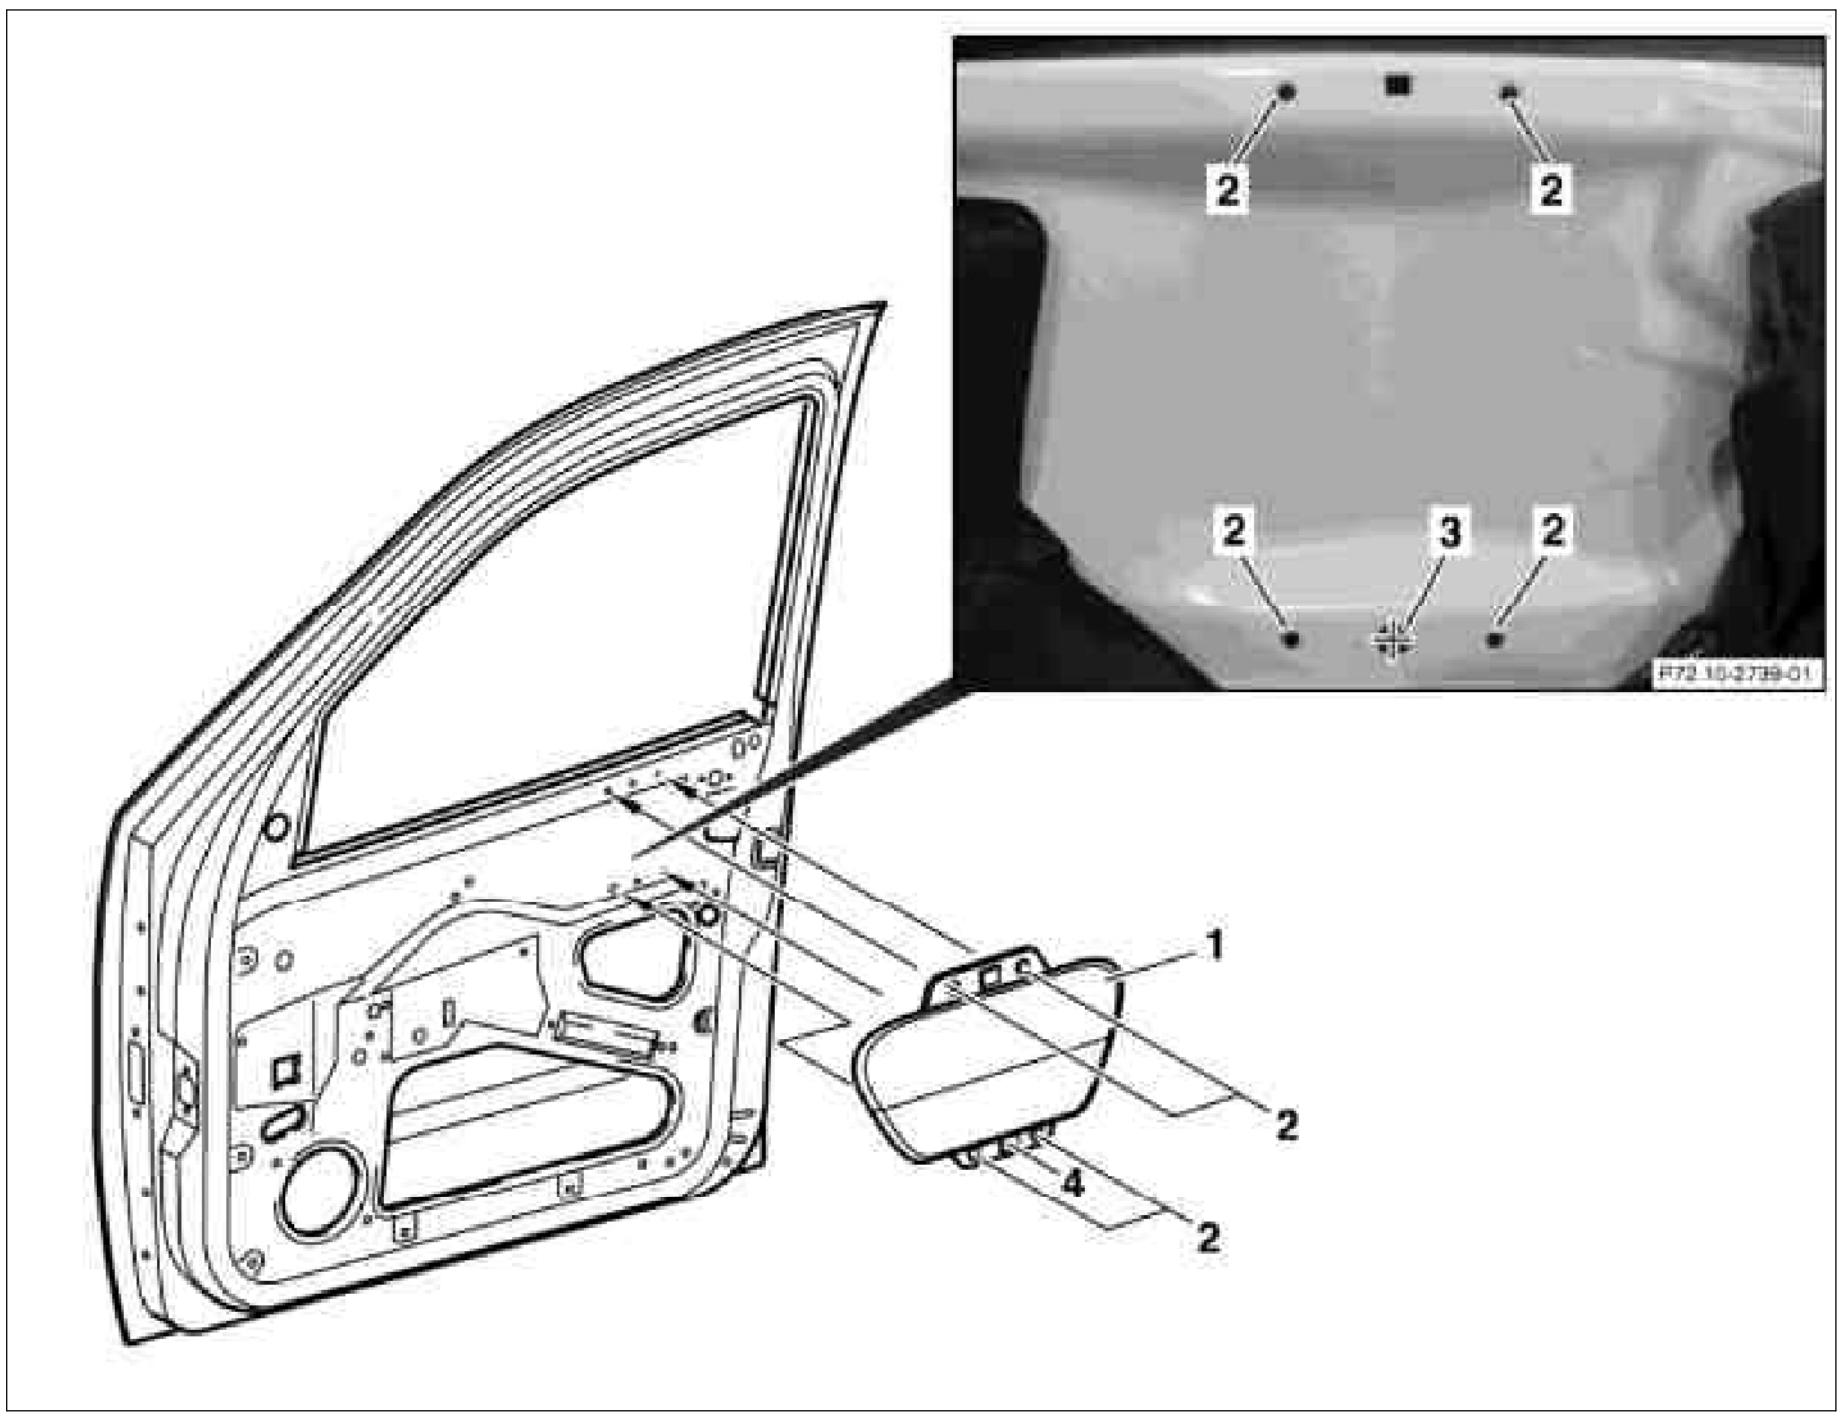
1 Side airbag
2 Attachment hole
3 Locating hole
4 Locating pin

ℹ Due to a design modification to the door skin, both parts must be checked when **exchanging** the door or the sidebag.

1	Check the replacement door to see if the aligning bore for the sidebag is present	ℹ Should the replacement door **not** have an aligning bore and the sidebag is equipped with a fixing pin: # Modify the front door	SM72.10-P-0004A
2	Check to see of the fixing pin is present for the replacement sidebag	ℹ If there is **no** fixing pin present on the sidebag, the door does **not** need to be modified.
